# BELZONA COATS SUPER YACHT

ID: 4805

Industry: *Marine*  
 Application: *SOS-Ships and Offshore Structures*

Substrate: *Aluminium/composite*  
 Products: *\* Belzona 1111 (Super Metal) ,*  
*\* Belzona 1341 (Supermetalglide) ,*  
*\* Belzona 2141 (ACR Elastomer) ,*

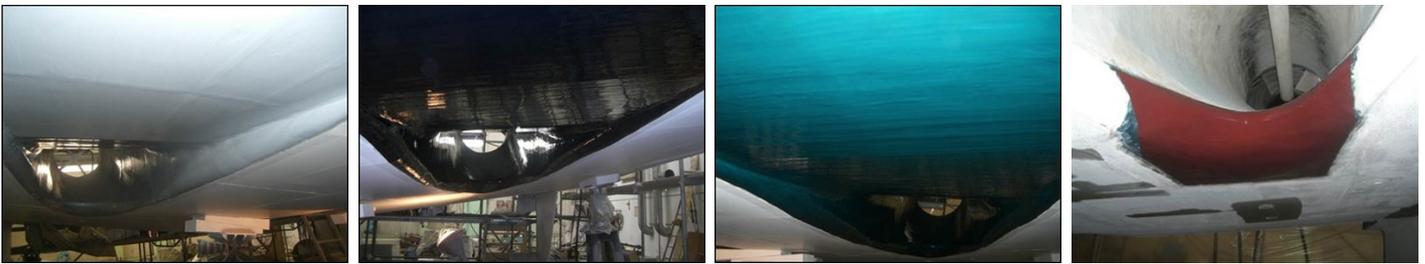
*Constructed with three Rolls-Royce gas turbine engines capable of pushing her to record speeds of 80knots, the jet tube area was suffering from high amounts of erosion and cavitation so when the vessel docked in Germany, Belzona provided a solution.*

- \* Jet tubes coated with Belzona 1341 ,
- \* 1st coat of Belzona 2141 ,
- \* 2nd coat of Belzona 2141 applied ,
- \* After three years in service local repair was carried out on leading edge ,

Application was carried out in accordance with Belzona Know-How System Leaflets SOS-1 & SOS-2. Rebuilding of the damaged area was carried out using Belzona 1111, before being coated with the Belzona 2141 system to provide cavitation resistance. Belzona 1341 was used as the first coat to provide optimum adhesion and corrosion resistance.

Belzona was inspected after 3 years and was mostly found to be in perfect condition with only minor damage to the leading edge. The coating had overcome the major cavitation erosion problems and was easily repaired with minimal downtime.
