BELZONA OFFERS IMPROVED SAFETY IN CHEMICAL PLANT

ID: 4807

Customer Location: Chemical Plant, UK
Application Date: 2010

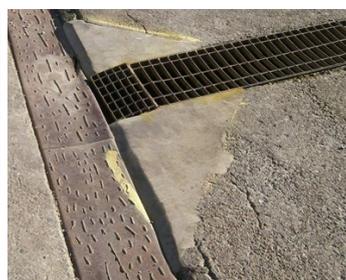
Photograph Descriptions

Over many years on this site, concrete surfaces had suffered attack from regular heavy lorry traffic, slab movement and from many chemicals. Concrete surfaces had been cracked or eroded in many areas around the plant, including access roads, pavements, expansion joints, bunds and plinths. Although some of these problems were structural, the main concern for the client was for the trip hazards around the site.

- * Example of typical concrete damage on road ,
- * Completed repair to road side ,
- * Completed repair to gully covers ,
- * Completed rebuild of forklift ramp ,

The customer had previously tried conventional cementitious repairs which had not performed well and was looking for a long lasting solution with a proven track record. For deep damage, the Belzona 4131 was bulk filled 50/50 with 6mm pea gravel and resin to reduce costs before topping with Belzona 4131. A total of 1700Kg of Belzona 4131 was used on site throughout the project. Following detailed inspections the client was delighted with the system and is considering its use on other sites with the same
