BELZONA PLATE BONDING SOLUTION FOR SLUDGE TANK

ID: 4808

Customer Location: Sewage treatment works, UK
Application Date: November 2013

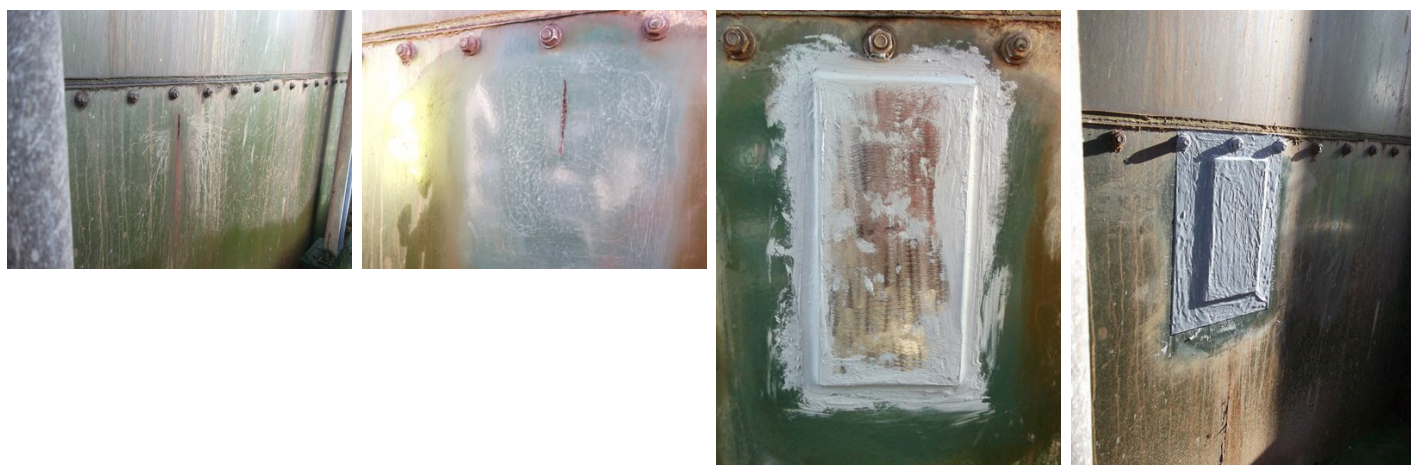
Photograph Descriptions

Tank was suffering from a through wall corrosion at the lowest panel level. The tank could not be taken off line due to demand and any repairs would have to be carried out without hot works or the use mechanical equipment due to the risk of sparks.

* 1. Through wall corrosion to primary sludge tank 2. Surface preparation carried out by hand abrasion 3. Repair plate cold bonded over the through wall corrosion using Belzona® 1161 4. Completed application ,

The application was carried out in accordance with Belzona Know-How System Leaflet TCC-3. A repair plate was cold plate bonded over the through wall defect using Belzona® 1161 before Belzona® 5831 was applied to the entire repair area.

The client required a fast solution as it was leaking effluent. Traditional repair methods required the tank off line for a minimum of a week. The Belzona solution was carried out live to keep the site running with minimal disruption and carried out without hot works
