BELZONA PROTECTION FOR NUCLEAR POWER STATION CW VALVES

Customer Location: Nuclear Power Station, UK
Application Date: December 2013

Butterfly valves controlling main cooling water inlets.

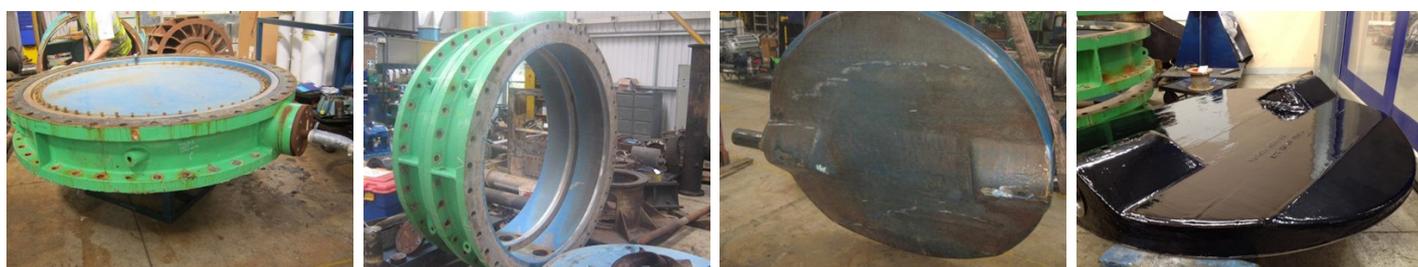
The non-pressure side of the valve had severely eroded due to corrosion and cavitation. The valve body and particularly the disc were affected.

- * MCW Butterfly Valve prior to dismantling ,
- * Valve body suffering erosion-corrosion ,
- * Non-pressure side prior to rebuild and coating ,
- * Non-pressure side rebuild and coated using Belzona 2141 ,

Application was carried out in accordance with Belzona Know-How System Leaflets VPF-1 & VPF-2. A hot chemical wash was used to remove salt contamination before completing the surface preparation and coating. The valve disc was coated with 3 coats of Belzona 2141 to provide maximum cavitation resistance. The valve body was protected from erosion-corrosion using Belzona 1321. In both cases the original profiles were restored by rebuilding with Belzona 1311.
