# BELZONA REPAIRED CELL ANTENNA MOUNTS ON WATER TANKS

ID: 4821

Customer Location: *Washington, USA*  
Application Date: *September 2013*

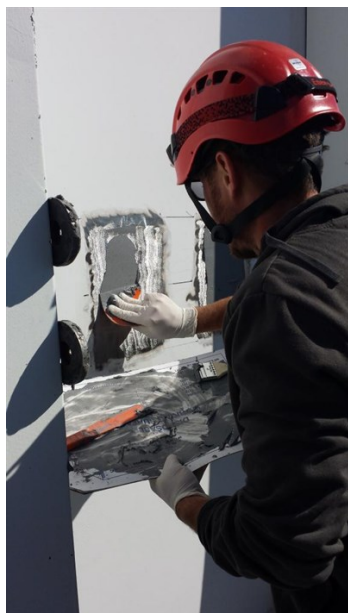
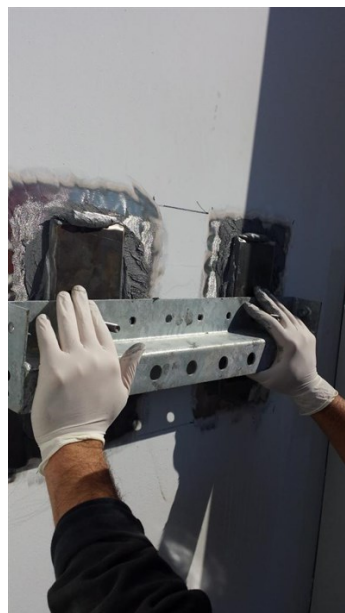
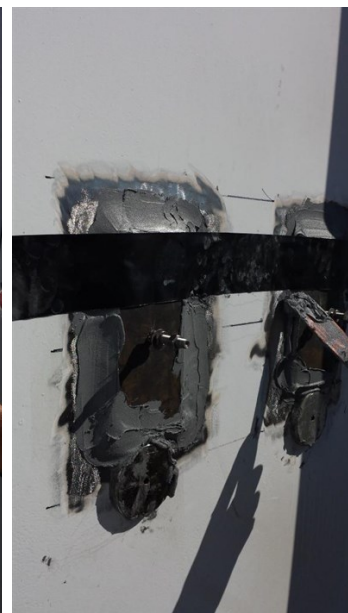
- \* Scrubbing Belzona 1111 onto mounting plate. ,
- \* Scrubbing Belzona 1111 onto Tank. ,
- \* Pressing plates onto tank with cross-bar to align correctly. ,
- \* Magnets under the plate to hold it up during cure, tape to keep plates from slipping sideways. ,

Grind 4" x 12" plates, chamfer edges. Grind or MBX bristle blast tank area. Mix and apply Belzona 1111 (or Belzona 1161, depending on the weather) to plates, high in the center. Apply the Belzona product to the tank and press the plate on. Proper alignment is critical. Use the excess Belzona product to build a fillet around the plate edges. We use one or two 90 degree magnets and Gorilla tape to hold the plates in place during cure. Minimum 48 hours before antennae are hung. Most cell phone companies require a Belzona Technical Consultant on site during application to assure Belzona guidelines are followed. The application was carried out in accordance with a modified version of Belzona Know-How System Leaflet TCC-1.
