# BELZONA REPAIRS AND PROTECTS LEAKING BALCONY

ID: 4823

Customer Location: *County Council, UK*  
Application Date: *November 2010*

90m long concrete balcony giving access to flats over shop units.

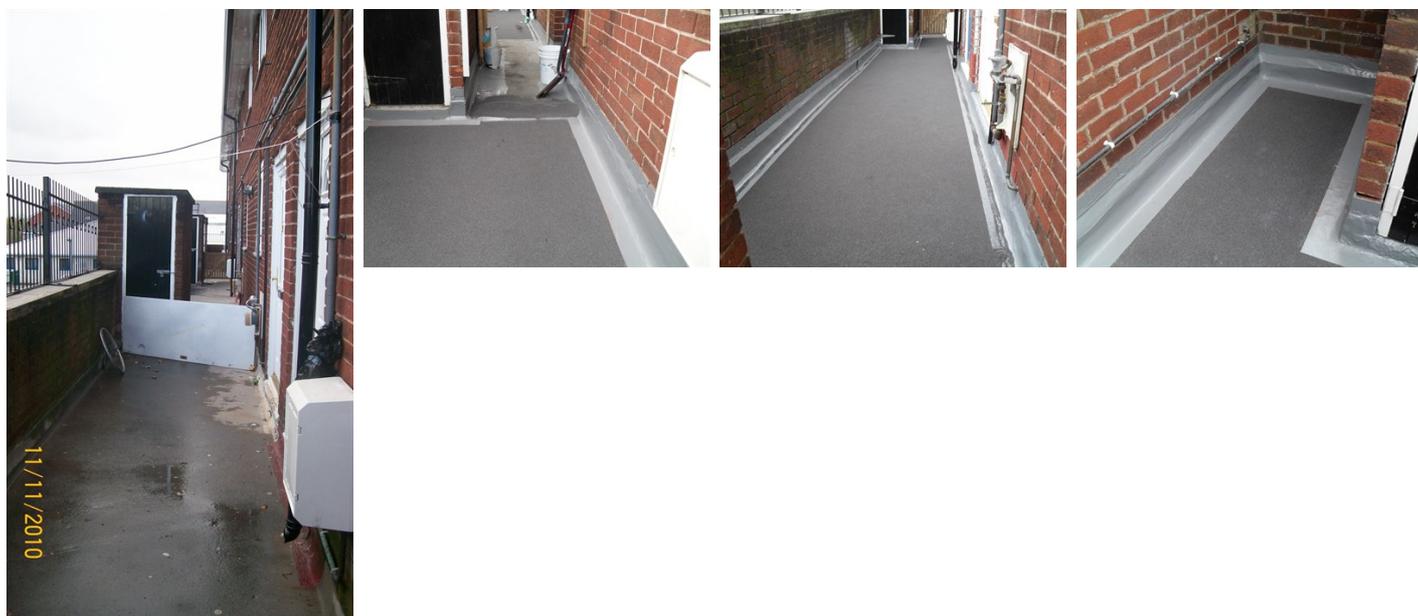
*Over the years the cantilevered balcony had dropped allowing a gap to form between wall and the balcony itself. There was then water ingress through the gap into the shops below.*

- \* Balcony before work commenced ,
- \* During the application ,
- \* Completed application ,
- \* Further view of the completed application ,

The application was carried out in accordance with Belzona Know-How System Leaflets RPA-2 & RPA-8. Belzona 4111 was used to rebuild damaged masonry and then the entire area was sealed with a fully reinforced Belzona 3111 system before applying a further coat of Belzona 3131 blended with Belzona 9231 aggregate to create a hard wearing non-slip surface.
