BELZONA REPAIRS HAZARDOUS OIL LEAK

Industry: Power
Application: VPF-Valves, Pipes and Fittings
Substrate: Mild steel
Products: * Belzona 1291 (ES-Metal) ,
* Belzona 1161 (Super UW-Metal) ,
* Belzona 5831 (ST-Barrier) ,

Customer Location: Power Station, Glasgow, UK
Application Date: September 2013

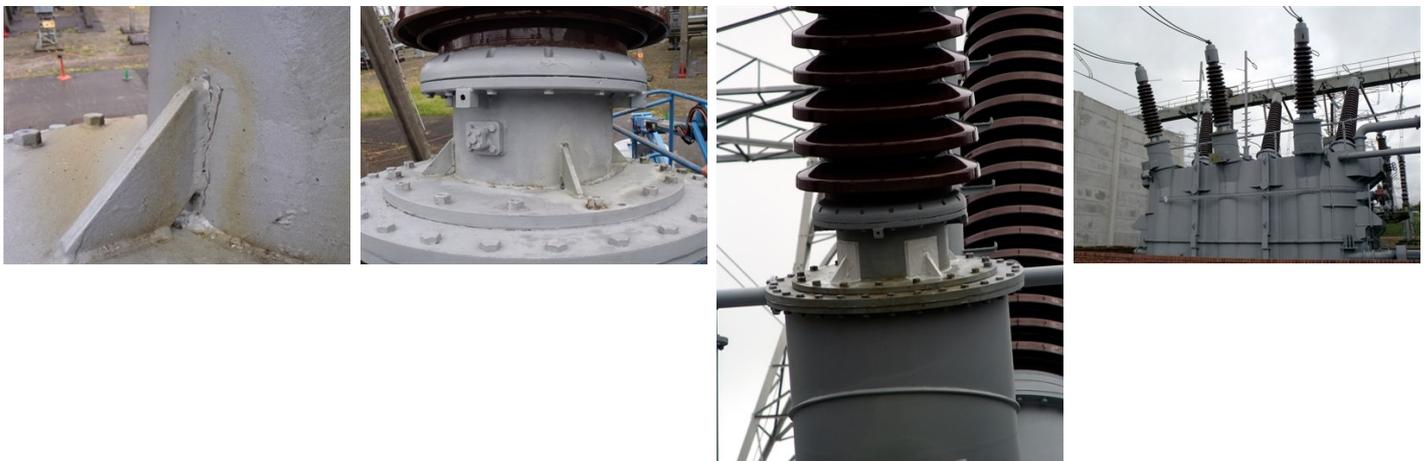
The two bushings were leaking oil. The leaks were coming from cracks in four steel support struts. These cracks were leaking oil and creating an environmental hazard.

- * View of one of the cracked struts ,
- * Bushing before application commenced ,
- * Completed application with plates bond in place ,
- * General view of the transformer after completing the repairs ,

Application was carried out in accordance with Belzona Know-How System Leaflets VPF-8 & VPF-11. The leaks were first stemmed using Belzona 1291. Pre blasted plates were then bonded into place around the struts, the purpose of these plates was to both seal the leaks and to give the structure back some strength so the cracks in the steel would not propagate. Belzona 5831 was applied to

give overall corrosion protection to the repaired areas.
