BELZONA PROTECTS HORIZONTAL FLARE KNOCK OUT VESSEL

ID: 487

Customer Location: Oil Refinery-Australia
Application Date: May 2004

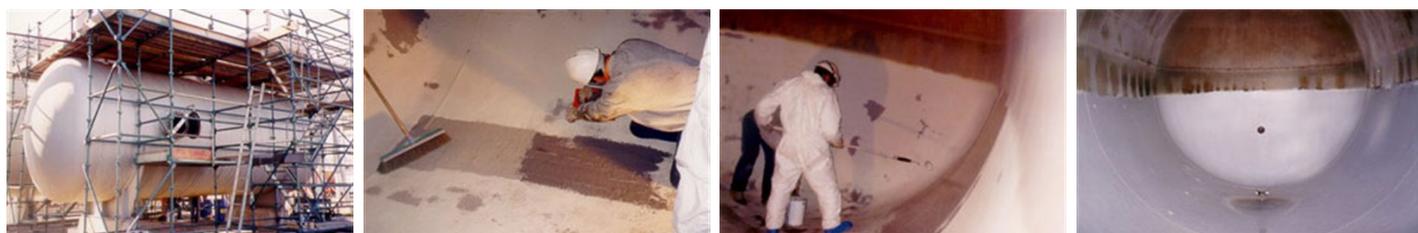
Photograph Descriptions

Corrosion in lower third of vessel where water sits. Vessel removes liquid hydrocarbon drop-out, H₂S and traces of HF.

- * Access to vessel ,
- * & 3. Localised pitting being infilled ,
- * 4. Completed application to lower section of the vessel ,

Application was carried out in accordance with Belzona Know-How System Leaflet TCC-5. After thorough cleaning, the vessel was grit blasted and coated with the Belzona® 5891.
