BELZONA PROTECTS PELTON TURBINE NOZZLE HEAD

ID: 4875

Customer Location: Hydro power plant, Kaunertal, Austria
 Application Date: May 2003

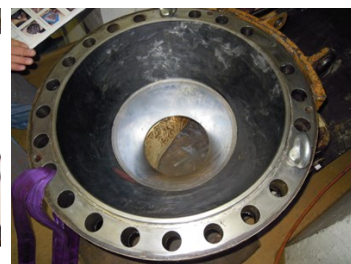
The nozzle head (hat) is exposed to a very high flow rate with a water pressure of 80 bar and with glacial debris in the water. Protection required to prevent erosion.

- * Nozzle head after grit blasting ,
- * Application of Belzona 2141 ,
- * Completed application before installation in May 2003 ,
- * After more than 10 years of operation Belzona 2141 in perfect condition ,

Application was carried out in accordance with Belzona System Leaflet VPF-2. After preparing surface by grit blasting (80 micron profile achieved) Belzona 2141 system was applied at 1mm thickness.

The Belzona system was originally applied in May 2003 and when inspected in February 2014 after more than 10 years in service was found to be in perfect condition.
