# BELZONA PROTECTS VERTICAL FLARE KNOCK OUT VESSEL

**Customer Location:** Oil Refinery-Australia  
**Application Date:** May 2004

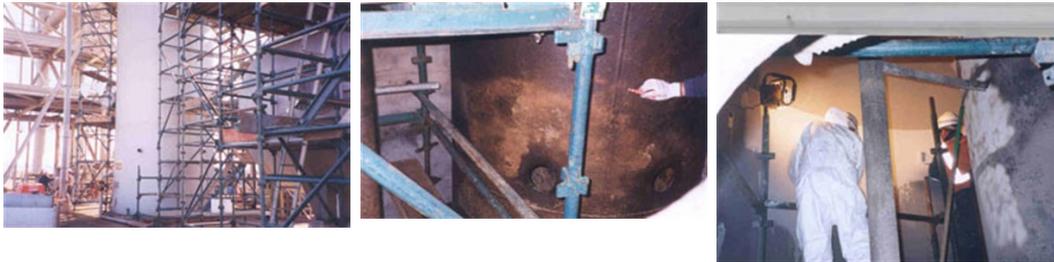
Internal corrosion caused by variety of hydrocarbons and chemicals passing through the vessel.

- \* General view of the vessel ,
- \* The degree of existing corrosion found in the vessel ,
- \* Application of Belzona® 5891 underway ,

Application was carried out in accordance with Belzona Know-How System Leaflet TCC-5. After thorough cleaning, the vessel was grit blasted and coated with the Belzona® 5891.
