# BELZONA SETS IN PLACE BRASS SLIDER PLATES ON A DRAGLINE

ID: 4884

Brass slider plates for a dragline

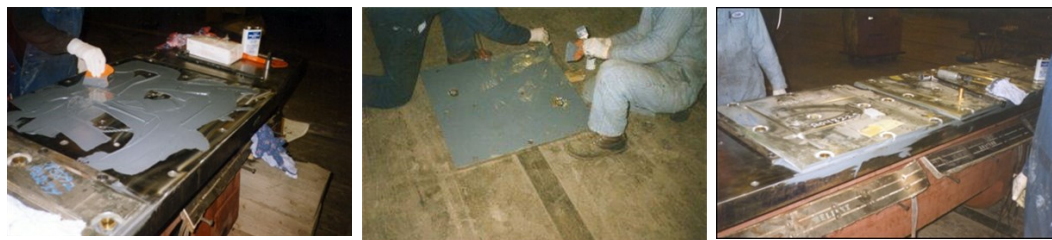
- \* Prepared surfaces coated with a 40 mil thickness coat of Belzona 1321 ,
- \* Applying Belzona 1321 on other plates ,
- \* The brass wear plates were inverted and the bolts torqued in place creating 100% contact ,

Belzona 1321 was floated in place to provide a non-shrinking shim successfully solving the problem.
