INVISIBLE WATERPROOF COATING FOR EXTERNAL WALLS

ID: 4905

Application: *WPA-Wall Problem Areas*

Customer Location: *Richmond Hill, Ontario, Canada*

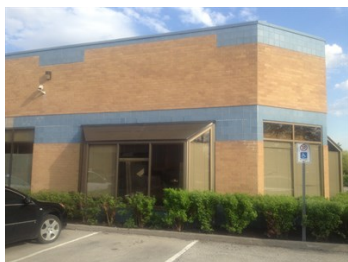
Water was penetrating the brick and mortar, creating damp areas on internal wall.

- * Walls prior to application ,
- * Preparation completed ,
- * Application underway ,
- * Completed application ,

The Application was carried out in accordance with Belzona Know-How System Leaflet WPA-8 - for water repellent treatment of external porous masonry. The surface was prepared to ensuring all contamination is removed. All loose substrate matter should be removed by grit blasting, wire brushing or scraping. Defective pointing should be raked out to a firm surface and re-pointed as necessary and windows or any paint work to be protected. Belzona 5122 was spray applied to the brick and mortar in accordance with the Belzona Instructions For Use.
