# INTERNAL COATING FOR CENTRIFUGAL PUMP

ID: 4922

**Industry:** Water / Wastewater  
**Application:** CEP-Centrifugal Pumps  
**Substrate:** Steel  
**Products:** \* Belzona 1321 (Ceramic S-Metal) ,  
\* Belzona 9111 (Cleaner Degreaser) ,

**Customer Location:** Niagara, Ontario, Canada  
**Application Date:** September 2013

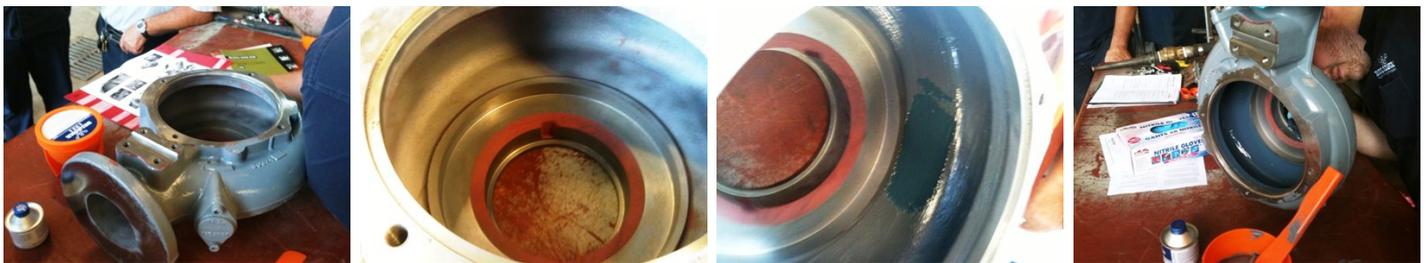
- \* Centrifugal Pump Prior to Application ,
- \* Preparation Complete ,
- \* Application ,
- \* Completed Application ,

Application was carried out in accordance with Belzona Know-How System Leaflet CEP-3. The surface was prepared by grit blasting the entire surface to be coated, brushing away any loose contamination and washing the surface with Belzona 9111. Belzona 1321 was applied directly on to the prepared surface with a stiff bristle brush in accordance with the Belzona Instructions For Use.
