BELZONA REPAIRS AND PROTECTS SX/EW TANKHOUSE CELL

ID: 4931

Customer Location: *Copper Mine, Arizona*
Application Date: *2011 - 2013*

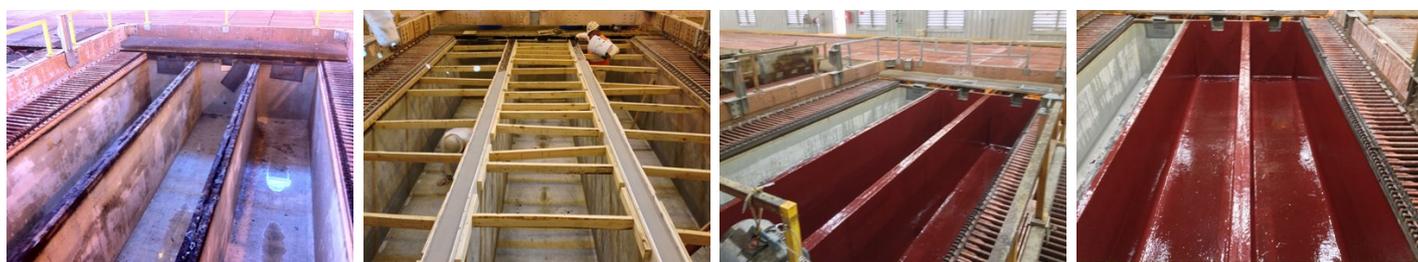
Photograph Descriptions

Polymer concrete SXEW process cells had been experiencing cracking which caused leakage of copper sulfate electrolyte solution. The furniture rails which suspend the copper anode plates were experiencing resin burnout from heat transfer through the cathodes.

- * Overview of the tankhouse cell ,
- * Furniture rails repaired with Belzona 4111 ,
- * Tankhouse cell protected with Belzona 4341 ,
- * Tankhouse cell protected with Belzona 4341 ,

The application was carried out in accordance with Belzona Know-How System Leaflet TCC-3. The cell surfaces were prepared by a combination of grit blasting and grinding. Then the furniture rails were formed and repaired with Belzona 4111. Finally Belzona 4341 was applied monolithically to prevent further damages.
