# BELZONA PROTECTS 50,000 SQ.FT FLOOR AREAS OF A TECHNOLOGY CENTER & LABORATORY

Application: *FPA-Floor Problem Areas*

Substrate: *Concrete*

Customer Location: *Copper Mine, Arizona*

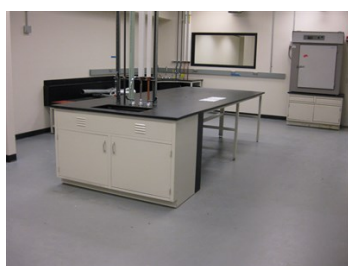
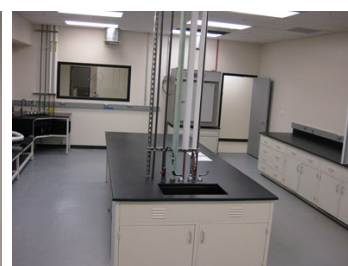
- \* Laboratory floor areas protected with Belzona 4311 ,
- \* Laboratory floor areas protected with Belzona 4311 ,
- \* General floor areas protected with Belzona 5811 ,
- \* Laboratory floor areas protected with Belzona 4311 ,

Application was carried out in accordance with Belzona Know-How System Leaflet FPA-3, following the 28 day curing process of the newly poured concrete. Belzona 5811 was applied to general floor areas and Belzona 4311 - to laboratory floors. The application of the coating systems was successfully completed using a combination of squeegee and paint rollers.
