# BELZONA PROTECTS 50,000 SQ.FT FLOOR AREAS OF A TECHNOLOGY CENTER & LABORATORY

ID: 4932

Application: *FPA-Floor Problem Areas*

Substrate: *Concrete*

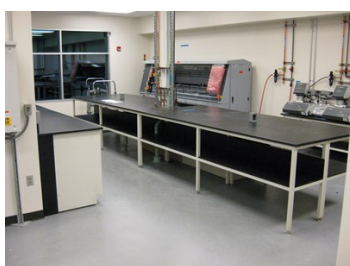
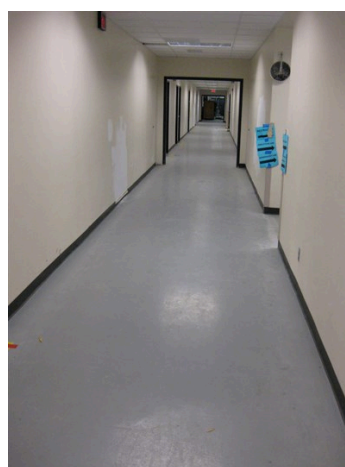
## Photograph Descriptions

- \* Laboratory floor areas protected with Belzona 4311 ,
- \* Laboratory floor areas protected with Belzona 4311 ,
- \* General floor areas protected with Belzona 5811 ,
- \* Laboratory floor areas protected with Belzona 4311 ,

Application was carried out in accordance with Belzona Know-How System Leaflet FPA-3, following the 28 day curing process of the newly poured concrete. Belzona 5811 was applied to general floor areas and Belzona 4311 - to laboratory floors. The application of the coating systems was successfully completed using a combination of squeegee and paint rollers.
