BELZONA PROTECTS 50,000 SQ.FT FLOOR AREAS OF A TECHNOLOGY CENTER & LABORATORY

Application: *FPA-Floor Problem Areas*

Substrate: *Concrete*

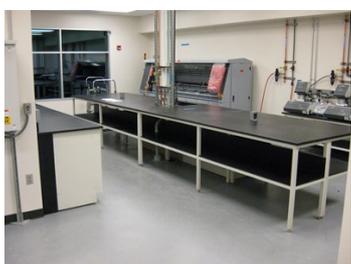
- * Laboratory floor areas protected with Belzona 4311 ,
- * Laboratory floor areas protected with Belzona 4311 ,
- * General floor areas protected with Belzona 5811 ,
- * Laboratory floor areas protected with Belzona 4311 ,

Application was carried out in accordance with Belzona Know-How System Leaflet FPA-3, following the 28 day curing process of the newly poured concrete. Belzona 5811 was applied to general floor areas and Belzona 4311 - to laboratory floors. The application of the coating systems was successfully completed using a combination of squeegee and paint rollers.
