# BELZONA USED IN MAJOR REFURBISHMENT OF 75-YEAR-OLD DAIRY

Customer Location: Dairy, Gloucestershire

Application: FPA-Floor Problem Areas

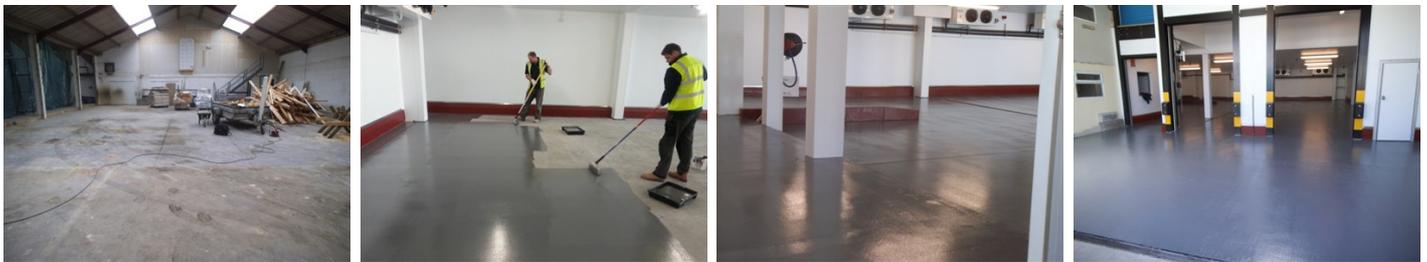
The dairy required several repair and maintenance solutions including localised repairs to the concrete floors, damage repairs to vertical columns, bonding on kerbstones and a non-slip, chemical resistant floor coating.

- \* Disused warehouse before application ,
- \* During application of Belzona 5231 ,
- \* & 4. Completed application ,

Application was carried out in accordance with Belzona System Leaflets FPA-1, FPA-3, FPA-11 and WPA-4. A slurry mix of Belzona 4111 was used to bond on the kerbstones. Belzona 4131 was used to repair several areas of concrete floor damage. The floor and kerbstones were coated with Belzona 5231. Belzona 4141 was used to repair damage to the vertical concrete columns.
