# SUCCESSFUL BELZONA REFURBISHMENT OF GUTTER

Customer Location: Interior furnishings showroom, Northern Ireland

Application: RPA-Roof Problem Areas

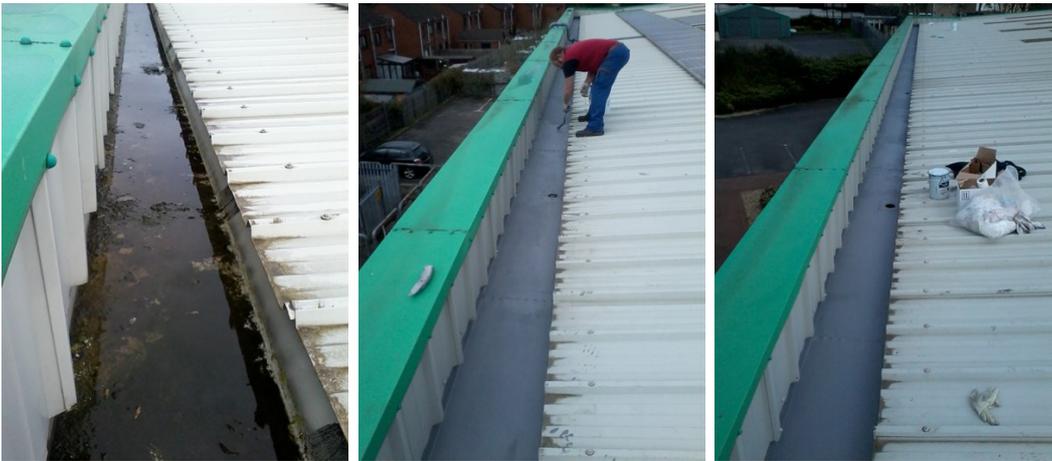
## Photograph Descriptions

The client has had consistent water ingress issues from the aluminium gutters, despite repeated attempts to seal the gutter joints and seams with silicone and bitumen products. The showroom area has suffered water damage on a regular basis.

- \* Gutters before application ,
- \* Conditioner applied ,
- \* Completed system ,

After thorough cleaning and drying of the substrate, application was carried out according with Belzona System Leaflet RPA-6. Belzona 3921 (GSC surface conditioner) was used to give optimum adhesion and a fully reinforced system incorporating Belzona 9311 (Reinforcing sheet) in the Belzona 3111 first coat was applied.
