Belzona® 3111 (Flexible Membrane) Protection in a Power Plant

ID: 504

Customer Location: Power Authority, San Antonio, Texas USA

Application Date: 2002

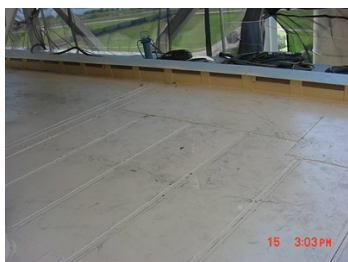
Water getting through collapsible roof seams wets coal and reduces fuel efficiency. Work area extremely dirty due to coal fines from belts.

- * Roof over cascade area prior to the application (note seams). ,
- * Seam areas taped off. ,
- * First coat of Belzona® 3111 applied. ,
- * Completed roof. (Roof was painted following the application of the Belzona.) ,
