# Belzona® 3111 (Flexible Membrane) Protection in a Power Plant

Customer Location: Power Authority, San Antonio, Texas USA

Application Date: 2002

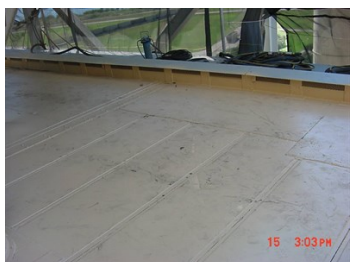
Water getting through collapsible roof seams wets coal and reduces fuel efficiency. Work area extremely dirty due to coal fines from belts.

- \* Roof over cascade area prior to the application (note seams). ,
- \* Seam areas taped off. ,
- \* First coat of Belzona® 3111 applied. ,
- \* Completed roof. (Roof was painted following the application of the Belzona.) ,
