Belzona® 3111 (Flexible Membrane) Protection in a Power Plant

ID: 504

Customer Location: Power Authority, San Antonio, Texas USA

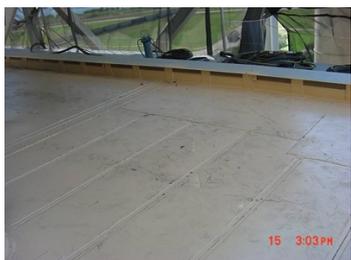
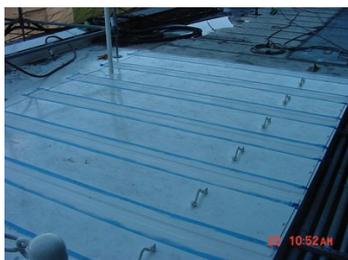
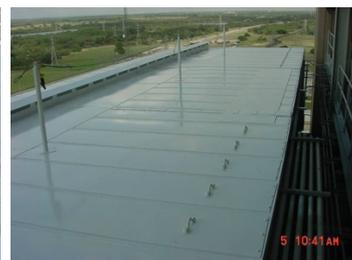
Photograph Descriptions

Water getting through collapsible roof seams wets coal and reduces fuel efficiency. Work area extremely dirty due to coal fines from belts.

- * Roof over cascade area prior to the application (note seams). ,
- * Seam areas taped off. ,
- * First coat of Belzona® 3111 applied. ,
- * Completed roof. (Roof was painted following the application of the Belzona.) ,

Collapsible roof over conveyor belts - in the area between the coalyard and the boiler.

Application was carried out in accordance with a modified version of Belzona® Know-How System Leaflet RPA-1.

Belzona® 3111 is ideal for waterproofing roofs where movement is present. Seams were designed into this roof as a safety precaution and the reinforced Belzona system ensures areas below stay dry.
