# LIFTING DEVICE FOR FENDER

ID: 508

Industry: Marine  
Application: SOS-Ships and Offshore Structures

Attaching metal lifting device to 800kgs rubber fender

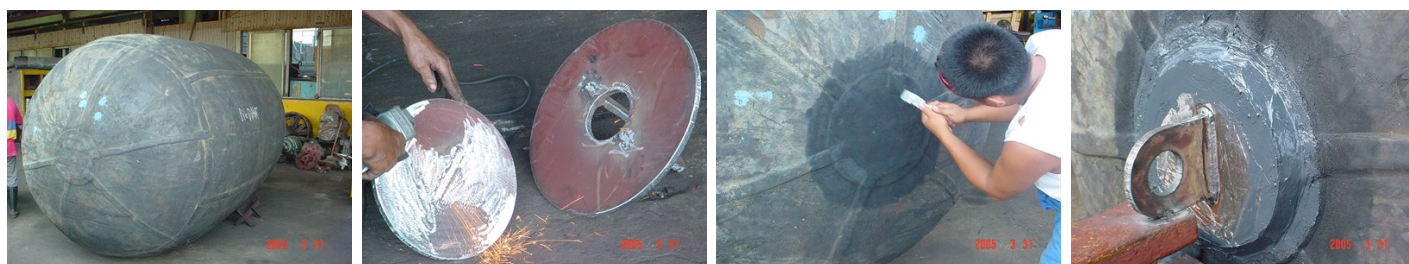
- \* Fender without lifting device ,
- \* A 12" diameter plate is prepared with lifting hook ,
- \* Surface preparation for the fender ,
- \* Finished application & metal lifting device is attached to the fender ,

The application was performed in accordance with Belzona Know-How System Leaflet SOS-12.

Previously, fenders are wrapped with tires tied with metal cables. On rough seas, ships paints get damaged by the metal cables. Putting a metal lifting device using Belzona® Elastomers was the right solution.
