# BELZONA PROVIDES FAST INTERIOR PROTECTION OF TWO CYANIDE DESTRUCTION TANKS

Industry: *Mining & Quarrying*  
Application: *TCC-Tanks and Chemical Containment Areas*  
Substrate: *Steel ASTM A36*  
Products: *\* Belzona 4151 (Magma-Quartz Resins) ,*

Customer Location: *Gold mine*  
Application Date: *September 2009*

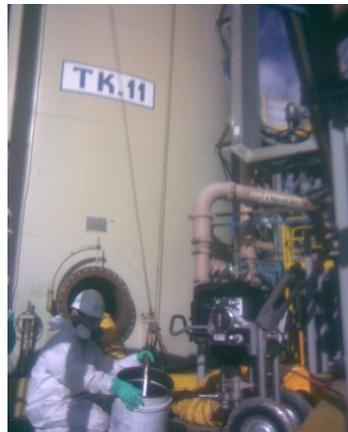
*Aggressive chemical attack, cavitation and erosion of suspended solids in processing tanks that operate with permanent entry and exit of fluids and mixing blades.*

- \* Original conditions in the interior of the tank ,
- \* Image of the tank and airless spray equipment ,
- \* Mixing Belzona 4151 ,
- \* Application completed ,

After blasting, Belzona 4151 was applied with airless spray equipment in accordance with Belzona Know-How System Leaflet TCC-5.
