Belzona internal lining to protect offshore process vessels

ID: 5170

Problem

New build vessel, corrosion and erosion protection

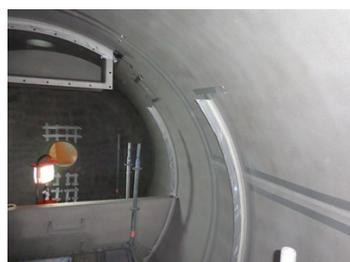
- * View of the HP Separator ,
- * Surface preparation completed and identification of the areas to be stripe coated ,
- * Spray application in progress ,
- * Completed application after inspection ,

Application carried out according to the project Method Statement and Quality Control Procedure. Belzona 1391T was used to stripe coat, prior to spray application of Belzona 1391S as a 2 coat system. Lining integrity inspection was carried out using a high voltage holiday detector (spark tester). Application was carried out in accordance with Belzona Know-How System Leaflets - TCC-5 for protecting and rebuilding steelwork
