# PICKLE TANK REPAIRED USING BELZONA PLATE BONDING

Customer Location: Automotive Parts Manufacturer, South Wales, UK

Application: TCC-Tanks and Chemical Containment Areas

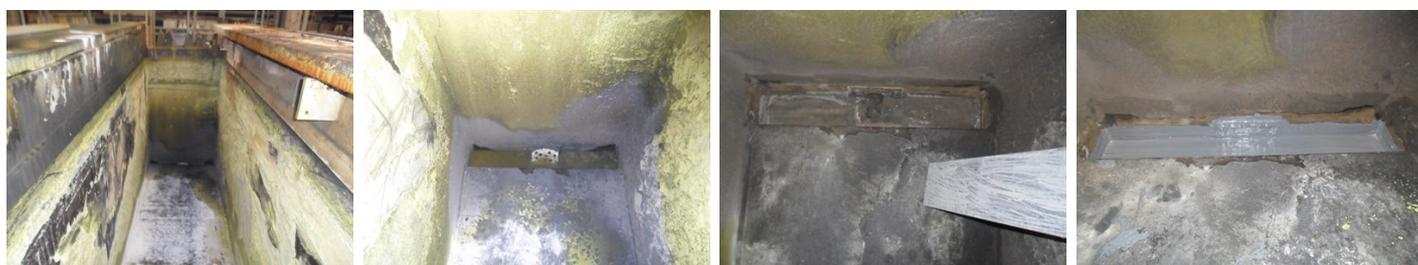
Corrosion issues prompted the Client to seek a cost effective solution to seal an internal-to-external drainage outlet. A swift application was required to eliminate any uncontrolled discharges of the acid to the internal working area.

- \* Tank location ,
- \* Pre-start ,
- \* Area preparation & pre-coated plate ,
- \* Application completed ,

Pickle tank containing 36% Hydrochloric acid, used in the process of decontaminating manufactured car parts through a system of wash baths.

The application was carried out in accordance with Belzona Know-How System Leaflet TCC-3. A mild steel plate, coated one side with Belzona 4311, was manufactured prior to attending site. The plate was bonded in place using Belzona 4301 and the edges sealed with further application of Belzona 4311.
