# BELZONA 1811 CERAMIC CARBIDE EXTENDS LIFE OF PUMP CASING

ID: 5198

Industry: *Mining & Quarrying*  
Application: *CEP-Centrifugal Pumps*  
Substrate: *Stainless steel*  
Products: *\* Belzona 1811 (Ceramic Carbide) ,*

Customer Location: *BC, Canada*  
Application Date: *June 2000*

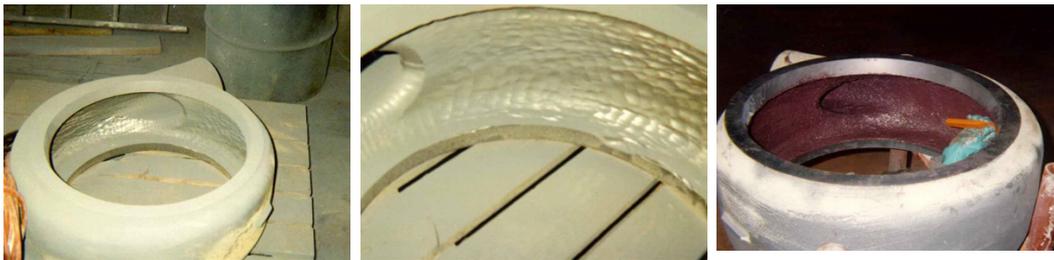
*Pumping drainage water from a gravel pit has a high percentage of entrained solids causing major erosion damage to pumps*

- \* View of Pump ,
- \* Close-up of pump showing extent of erosion ,
- \* The internal surfaces of the pump casing are protected with Belzona 1811 ,

Erosion on gravel slurry pump

Application carried out in accordance with a modified version of Belzona Know-How System Leaflet CEP-1

Coating the internal surfaces with a sacrificial coating such as Belzona 1811 ensures that the pump casing can be recycled many times over
