# BELZONA REDUCES DOWNTIME WITH SHAFT REPAIR

ID: 5216

Industry: *General Industry*  
Application: *FBC-Fans, Blowers and Compressors*

Bearing shaft.

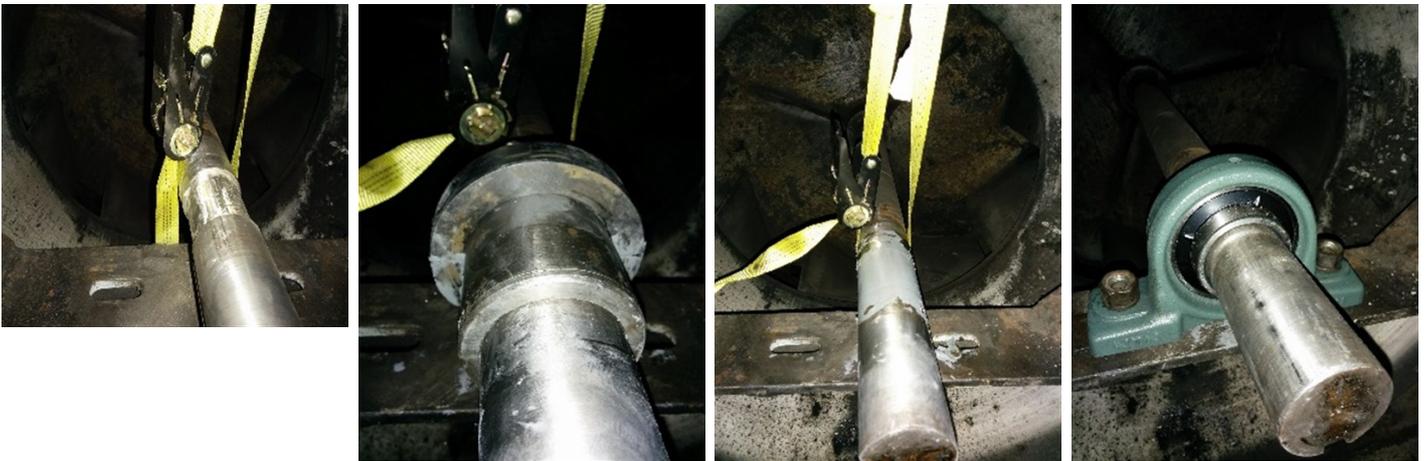
*Bearing failure caused severe scoring to shaft.*

- \* Prior to application ,
- \* Preparation in process ,
- \* Completed application ,
- \* Completed application in service ,

The application was carried out in accordance with Belzona Know-How System Leaflet FBC-13 for repairing shafts by forming techniques. The surface was prepared by mechanical grinding and cleaning with Belzona 9111 to remove all residue. The former's interior was prepared with Belzona 9411. Belzona 1111 was applied to the shaft and former, and the former was installed on the

shaft. After curing, the former was removed and the shaft was checked for fit tolerance.
