# EXPANSION JOINTS REPAIRED WITH BELZONA

Industry: Buildings & Structures  
Application: FPA-Floor Problem Areas  
Substrate: Concrete  
Products: \* Belzona 2131 (D & A Fluid Elastomer) ,  
\* Belzona 2911 (Elastomer QD Conditioner) ,

Customer Location: London, ON, Canada  
Application Date: May 2014

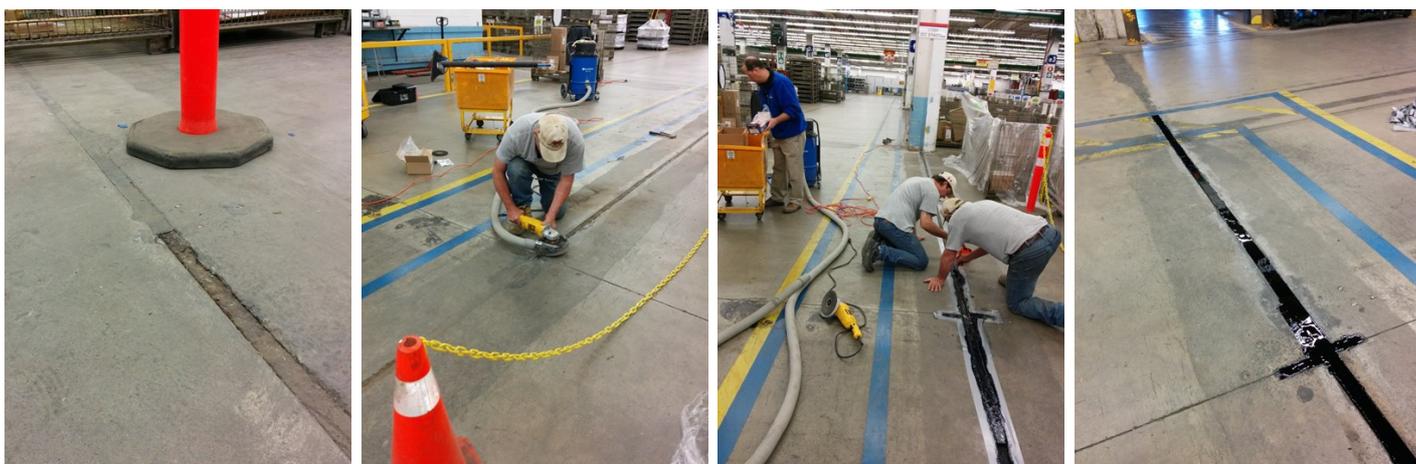
The previous joint had failed, and the area of the floor was closed off to fork lifts and handling equipment.

- \* Prior to application ,
- \* Preparation in progress ,
- \* Application in progress ,
- \* Completed application ,

The application was carried out in accordance with Belzona Know-How System Leaflet FPA-6 for replacing expansion joint sealants. The concrete was prepared by removing the existing expansion joint by hand and with a hand grinder, together with a vacuum to drastically reduce the dust to clean the concrete. The application area was taped and Belzona 2911 was applied over the entire joint area. Then Belzona 2131 was poured into the joint. The tape was removed after application.
