Belzona, the Alternative to Welding in Difficult Situations

Industry: *General Industry*
Application: *TCC-Tanks and Chemical Containment Areas*
Substrate: *Carbon Steel*
Products: ** Belzona® 1111 (Super Metal) ,*

Customer Location: *Vegetable Oil Processor - Liverpool, UK*
Application Date: *March 2005*

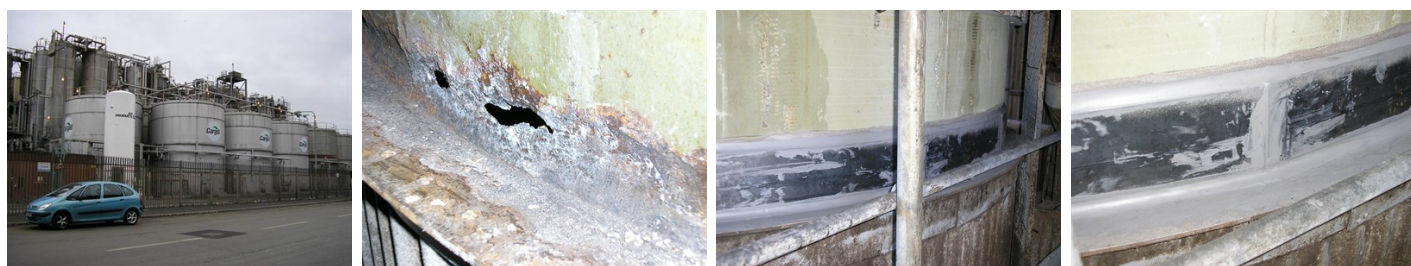
The tank was experiencing classic Corrosion Under Insulation caused by water ingress that was sitting on the lagging bands around the tank and soaking through the lagging. The problem was further exacerbated by the elevated temperature of the tank. Problem made still worse by the lining material being highly volatile requiring a Nitrogen shroud before and during any potential welding operations.

- * Scenic view of the tank farm. ,
- * Damage to tank wall. ,
- * The Belzona repair. After surface preparation to achieve profile the profiled plates were bonded in place with a fillet of Belzona material between them to allow excess water to run off. ,
- * Close up of repair area. ,
