BELZONA PROTECTS CENTRIFUGAL PUMPS AGAINST EROSION-CORROSION

ID: 5230

Industry: Fluid Flow
Application: CEP-Centrifugal Pumps
Substrate: Cast iron and Steel
Products: * Belzona 1121 (Super XL-Metal) ,
* Belzona 1341N (Supermetalglide) ,

Customer Location: KS, USA
Application Date: 2004-2005

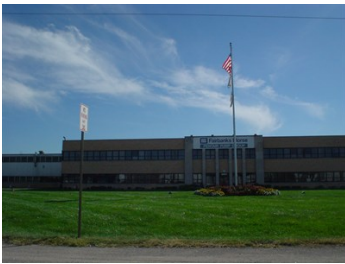
- * View of Fairbanks-Morse Pentair Pump Group ,
- * Centrifugal pump prior to application ,
- * Application in progress ,
- * Completed application ,

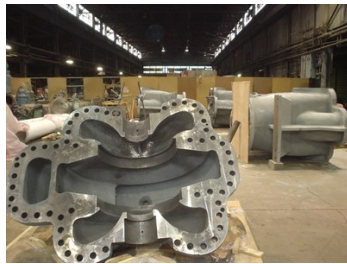
The project, consisting of ten new centrifugal pumps destined for a municipal facility, was experiencing difficulties in achieving consistent performance specifications due to the extremely irregular and rough castings.

Belzona offered a perfect compliment to these new potable water service pumps. The application was carried out in accordance with Belzona Know-How System Leaflets CEP-1, CEP-5 and CEP-10 using Belzona 1121 and two coats of Belzona 1341N.
