BELZONA PROTECTS CENTRIFUGAL PUMPS AGAINST EROSION-CORROSION

Industry: Fluid Flow
Application: CEP-Centrifugal Pumps
Substrate: Cast iron and Steel
Products: * Belzona 1121 (Super XL-Metal) ,
* Belzona 1341N (Supermetalglide) ,

Customer Location: KS, USA
Application Date: 2004-2005

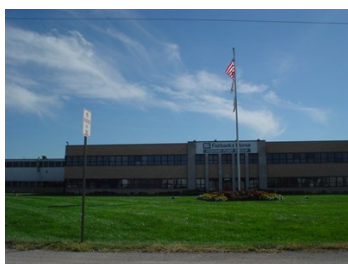
- * View of Fairbanks-Morse Pentair Pump Group ,
- * Centrifugal pump prior to application ,
- * Application in progress ,
- * Completed application ,

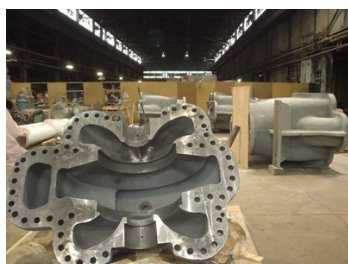
The project, consisting of ten new centrifugal pumps destined for a municipal facility, was experiencing difficulties in achieving consistent performance specifications due to the extremely irregular and rough castings.
