# BELZONA SAVES PUMP FROM REPLACEMENT

ID: 5231

Industry: *Fluid Flow*  
Application: *CEP-Centrifugal Pumps*  
Substrate: *Cast iron and Steel*  
Products: *\* Belzona 1341 (Supermetalglide) ,*  
*\* Belzona 1121 (Super XL-Metal) ,*

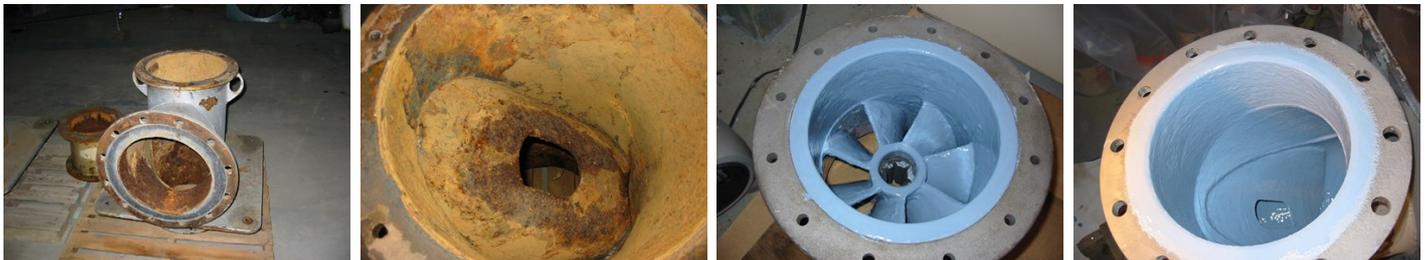
*The pumps from one of this well-known amusement park's water rides had badly corroded with severe loss of metal. The corrosion was so thick that the pumps required grit blasting three times to achieve a proper profile. A solution was sorely needed.*

- \* Overview of the pump ,
- \* Sever corrosion damage to the pump ,
- \* Completed application ,
- \* Completed application ,

The most severe corrosion areas were repaired with Belzona 1121 followed by two coats of Belzona 1341 to provide a long-lasting, super slick surface. The application was carried out in accordance with Belzona Know-How System Leaflets CEP-1 & CEP-10.
