# BELZONA PROTECTS CO2 ABSORBER TOWER

ID: 5232

**Customer Location:** Fertilizer plant, Bulgaria

CO2 Absorption tower 41m high, 4m diameter - lower part

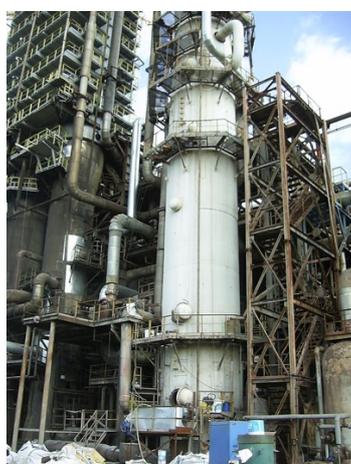
\* 1. General view of the tower 2. Severe pitting was revealed after surface preparation by abrasive blasting 3. Application of the first coat of Belzona 1391 underway 4. View of the final application. Belzona 1391 was applied in two coats with grit blasting between the first and the second coat ,
