BELZONA PROTECTS CO2 ABSORBER TOWER

ID: 5232

Customer Location: Fertilizer plant, Bulgaria
Application Date: August, 2014

CO2 Absorption tower 41m high, 4m diameter - lower part

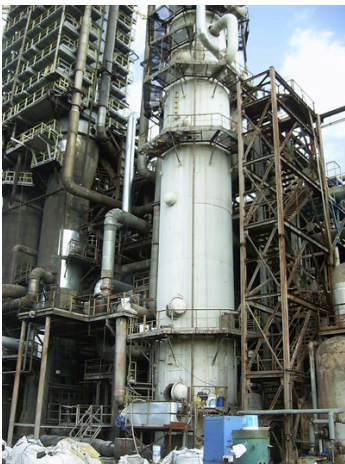
* 1. General view of the tower 2. Severe pitting was revealed after surface preparation by abrasive blasting 3. Application of the first coat of Belzona 1391 underway 4. View of the final application. Belzona 1391 was applied in two coats with grit blasting between the first and the second coat ,

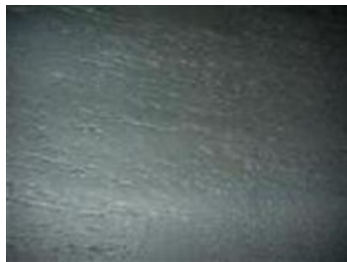
Vessel was working without lining and suffering severe internal corrosion due to presence of amines MEA/MDEA at elevated temperature up to 100°C. Coating required to extend service life of the vessel.

Application was carried out in accordance with Belzona Know-How Leaflets TCC-3 & TCC-5. Belzona® 1311 was used to repair pitting and to smooth out weld repairs before the lower part of the vessel was coated with Belzona® 1391.
