BELZONA PROTECTS SPRAY CASTER FAN

ID: 5234

Industry: Power
Application: FBC-Fans, Blowers and Compressors

Customer Location: Steel Mill, South Carolina
Application Date: July 2011

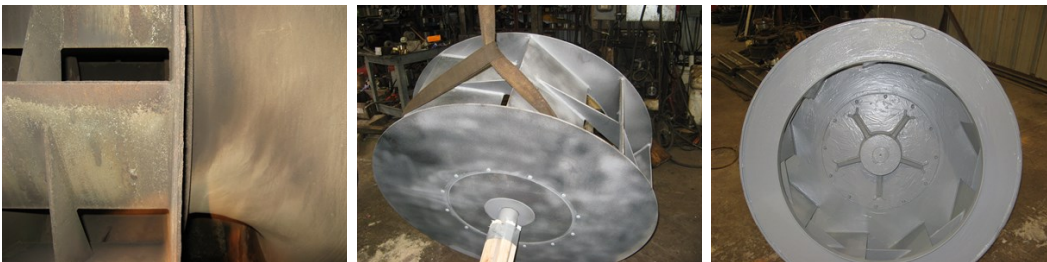
Photograph Descriptions

Pitting, erosion, corrosion, delamination and accumulation of dirt from the humidity prematurely degrades the life expectancy of the fan blades. Additionally, cleaning and balancing are difficult due to dust penetration and clinging to the blades.

- * Spray Chamber Caster Fan showing pitting, corrosion ,
- * Impeller fan blade after grit blasting ,
- * Spray caster with first coat of Belzona 5891 ,
- * Bottom of spray caster wheel after second coat of Belzona 5891 ,

Application was carried out in accordance with Belzona Know-How System Leaflet FBC-2 and the IFU for Belzona 5891. Fan was grit blased with sand, cleaned with Belzona 9111 and two coats of Belzona 5891 applied.

Belzona 5891 HT was selected because it met the temperature exposure limits as well as the chemical exposure contained in the water. Customer has coated two fans that are still in service today. Previously, they were replacing spray caster fans every 18
