# BELZONA PROTECTS PARAPET WALLS FROM WATER PENETRATION

ID: 5240

Customer Location: *Toronto, ON, Canada*  
Application Date: *August 2013*

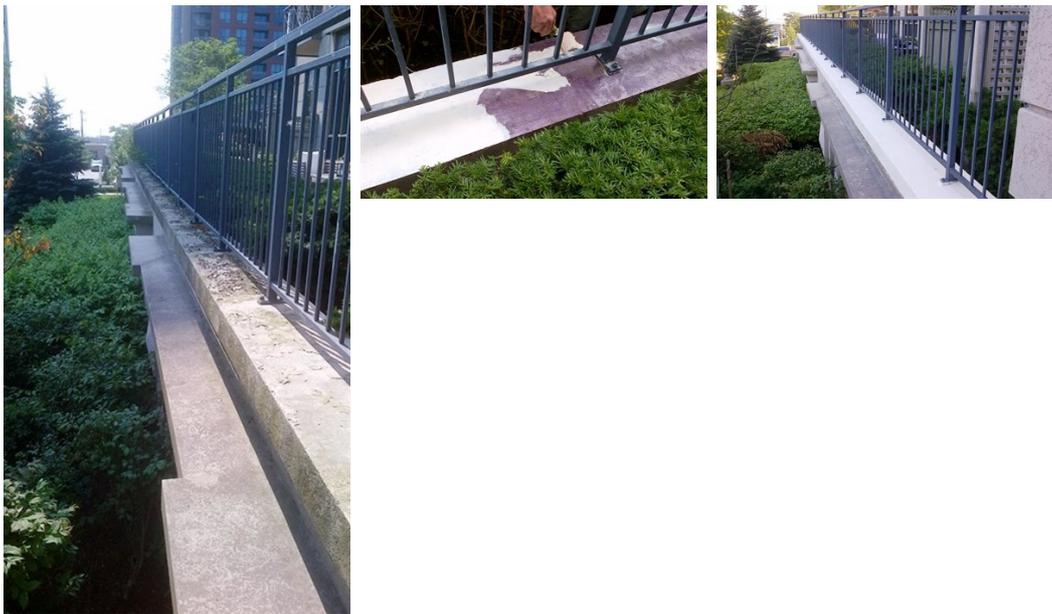
*Water was penetrating the concrete.*

- \* Prior to application ,
- \* Application in progress ,
- \* Completed application ,

Parapet walls of a condominium building.

The application was carried out in accordance with Belzona Know-How System Leaflet RPA-10 for sealing leaking areas in parapet walls and copings. A wire brush was used to prepare the surface and brushed off to remove all the dust. Belzona 3911 was applied

with a brush to the entire surface. Belzona 5131 was applied with a lambs wool roller in accordance with Belzona Instructions For Use.
