BELZONA PROTECTS POWER PLANT CONDENSERS

ID: 5241

Customer Location: Power Plant, Bulgaria
Application Date: March-June,2014

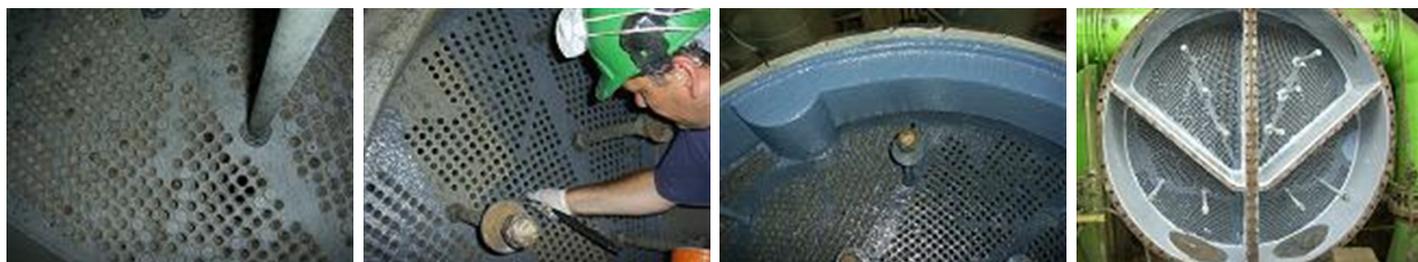
Photograph Descriptions

Corrosion/erosion on the turbine condensers (heat exchangers) after years of operation. Originally un-lined, extensive bimetallic corrosion had occurred between brass tubes and carbon steel tube sheets.

* 1. Surface preparation of tube sheet by blast cleaning 2. Coating of tube sheet with Belzona® 1321 3. Application of first coat of Belzona® 1341 to water box 4. Completed application to tube sheet and water box ,

Application was carried out in accordance with Belzona Know-How Leaflet HEX-3. Belzona® 1321 was used to protect tube sheets from bimetallic corrosion and erosion from entrapped particles in the cooling water. Belzona® 1341 was used to protect the water boxes.

Belzona application has been done separately for each condenser thus providing uninterrupted operation of the power plant. Coating of tube sheet surface with Belzona 1321 was completed in one day. Then the water boxes and covers were coated with Belzona® 1341 over two days. Complete application done within a week thus the equipment has been put in service with minimum delay. Belzona application provides power plant with long term erosion/corrosion protection of both condensers.
