# BELZONA OFFERS SLIP RESISTANT COATING ON STAIRCASE

ID: 5243

Staircase access to car park.

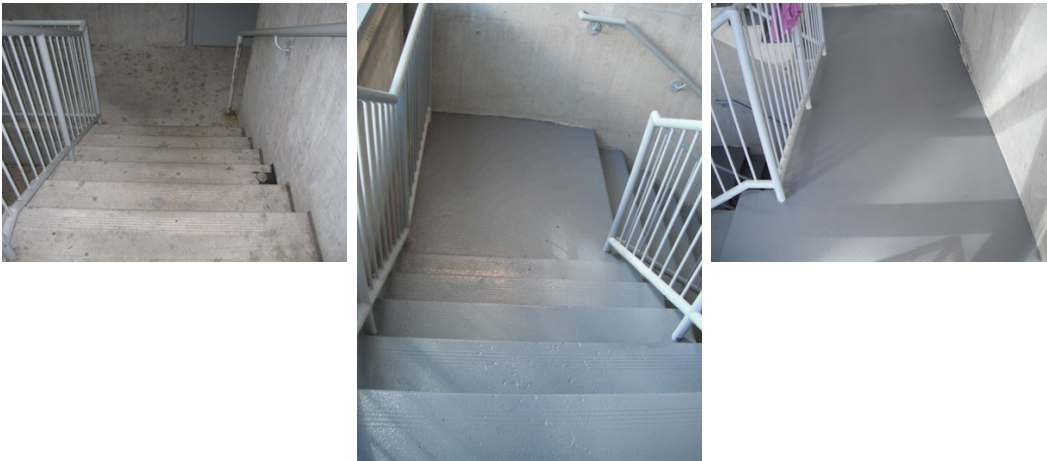
The customer wanted a coating that was slip resistant and offered protection from salt contamination.

- \* Prior to application ,
- \* Completed application ,
- \* Completed application ,

The application was carried out in accordance with Belzona Know-How System Leaflet FPA-3 for protecting floors and drains against chemical attack. The surface was prepared by power washing the surface to remove dirt, debris and salt contamination. A diamond grinder was used to abrade the surface and remove small floor imperfections. Belzona 5231 was applied for the first coat and Belzona 9221 was broadcasted for increased antiskid properties. A second coat of Belzona 5231 was applied within the overcoat window in accordance with Belzona Instructions For Use.
