# BELZONA COATS FLOORS FOR PROTECTION AGAINST CHEMICAL ATTACK

ID: 5245

Customer Location: *Burlington, ON, Canada*  
Application Date: *May 2014*

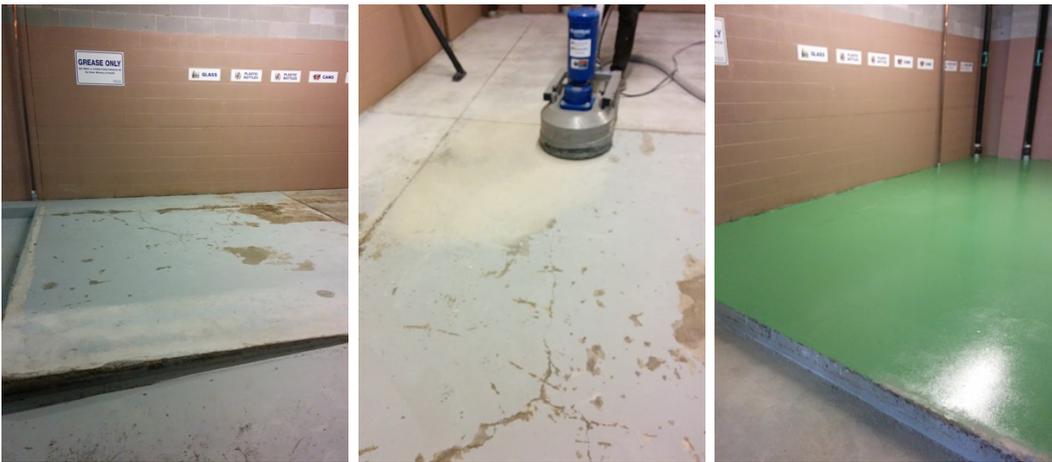
*Waste was causing chemical attack so the customer wanted a coating to protect the flooring.*

- \* Prior to application ,
- \* Preparation in progress ,
- \* Completed application ,

Garbage room floors in a mall.

The application was carried out in accordance with Belzona Know-How System Leaflet FPA-3 for protecting floors and drains against chemical attack. The floor was prepared for coating using a floor sander to remove any existing coating, dirt and debris and abraded to expose the aggregate. Belzona 5231 was applied using a medium nap roller in accordance with Belzona Instructions For Use.
