BELZONA MOUNTS CELL PHONE ANTENNAS

ID: 5249

Customer Location: *Spokane, WA, USA*
Application Date: *August 2013*

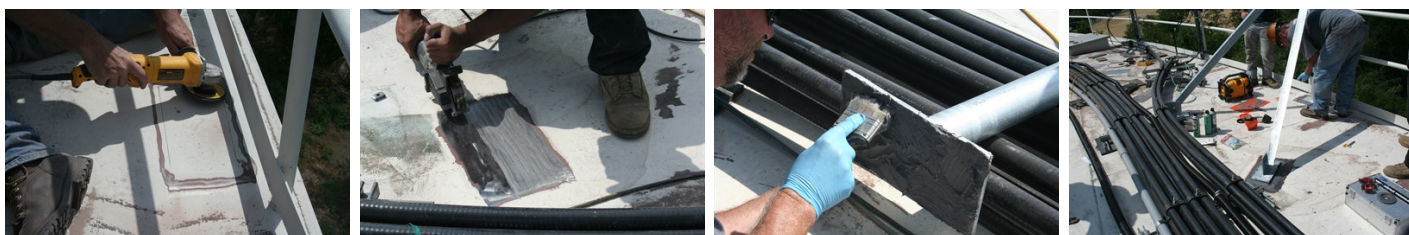
Photograph Descriptions

- * Preparing the area 1" wider than the plate all the way around for proper application. ,
- * Final surface preparation using the MBX Bristle Blaster. ,
- * Scrubbing it in with a brush. ,
- * Putting it in place. Job completed. ,

The IFU for the Belzona 1111 was followed. The MBX Bristle Blaster was used to prepare the tank. A grinder with a coarse wheel was used to prepare the plates. Non-chlorinated cleaner was used to clean the surfaces prior to the application.
