HD CLEANER CONE REPAIRED WITH BELZONA

ID: 5252

Industry: *Pulp & Paper*

Application: *SHM-Solids Handling Machinery*

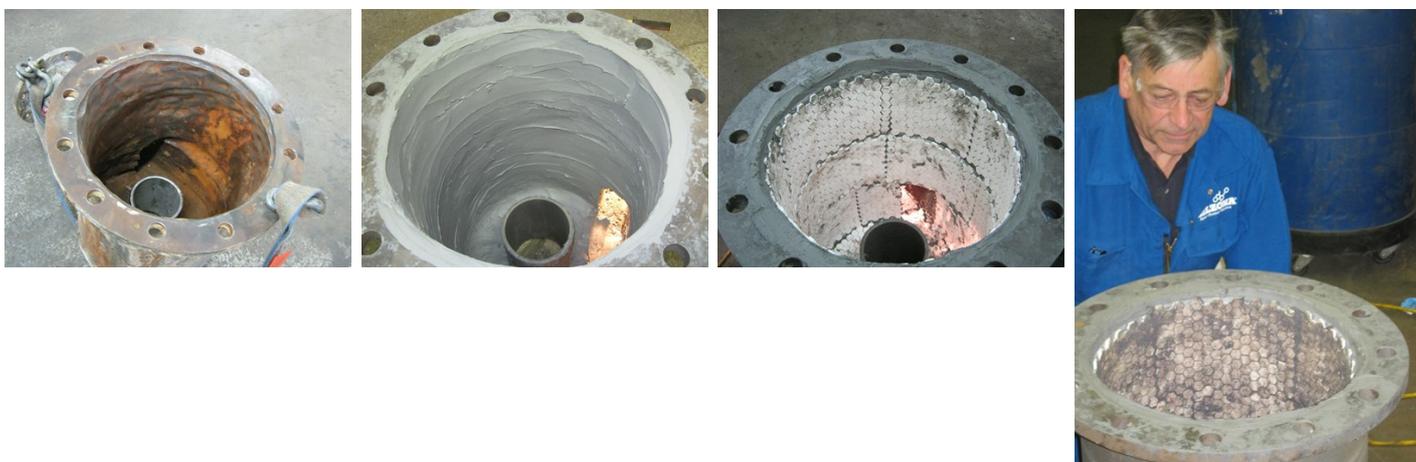
Photograph Descriptions

Abrasion caused by removal of unwanted solids from pulp paper.

- * Prior to application ,
- * Application in progress ,
- * Application in progress ,
- * Completed application ,

High Density (HD) cleaner cone.

The application was carried out in accordance with Belzona Know-How System Leaflet SHM-7 for bonding and grouting tiles and wear plates. The cone was blasted to prepare the surface before application. Belzona 1121 was applied with an applicator, filling all the worn areas and reprofiling the cast iron. Belzona 9811 was bonded to Belzona 1812 and grouted in between the tiles after they

were all bonded.
