STEEL OF A RAILWAY PROTECTED WITH BELZONA

ID: 5253

Industry: *Transport*
Application: *FPA-Floor Problem Areas*
Substrate: *Steel*
Products: ** Belzona 4151 (Magma-Quartz Resin) ,*

Customer Location: *Kitchener, ON, Canada*
Application Date: *March 2013*

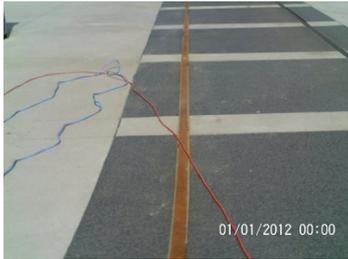
Corrosion on the steel of a railway.

- * Prior to application ,
- * Preparation in progress ,
- * Preparation in progress ,
- * Completed application ,

The application was carried out in accordance with Belzona Know-How System Leaflet FPA-3 for protecting floors and drains against chemical attack. A MBX bristle blaster was used to remove any rust and to prepare the surface for application. Belzona 4151 was brush applied in accordance with Belzona Instructions For Use.
