BELZONA MAKES THE CABLE RUN

Industry: *General Industry*
Application: *TCC-Tanks and Chemical Containment Areas*
Substrate: *Steel*
Products: ** Belzona 1161 (Super UW Metal) ,*

Customer Location: *Zillah, WA, USA*
Application Date: *December 2013*

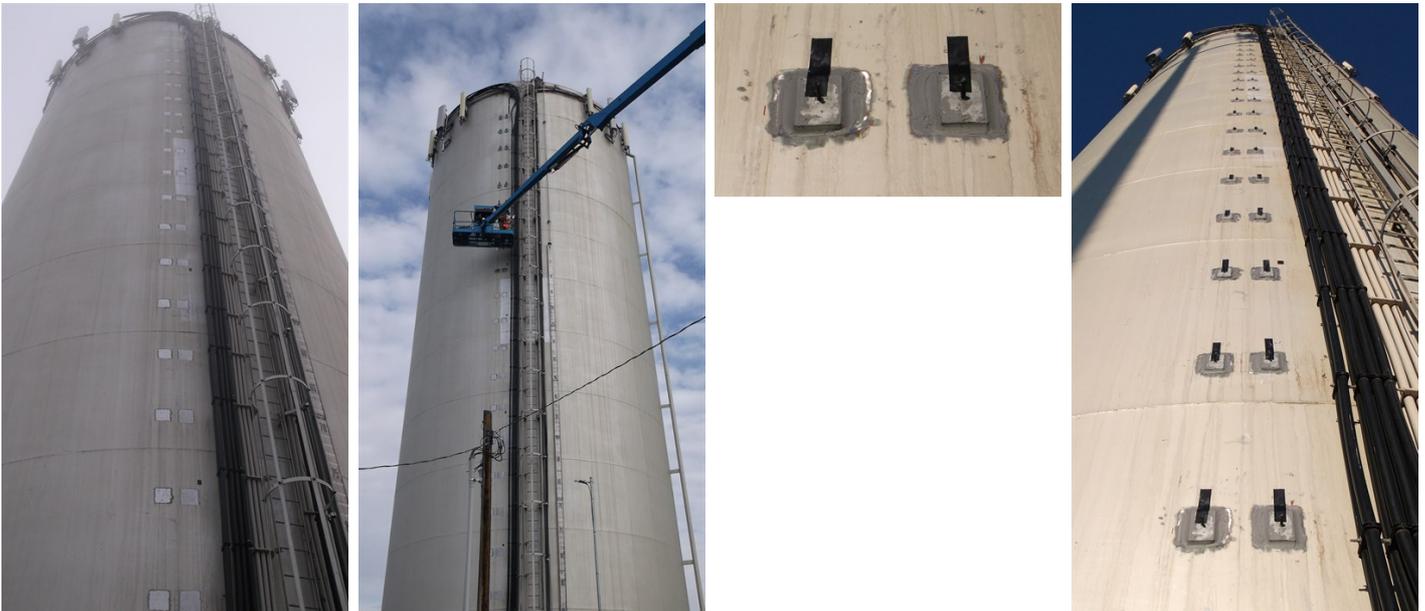
Photograph Descriptions

- * 1. Initial preparation complete, paint removed. ,
- * 2. Partially complete ,
- * 3. 'Gorilla' tape being used to help the 4"X4" plates stay in place until the Belzona 1161 has cured. Also tape on the threads of the studs so the Belzona 1161 does not get on them. ,
- * 4. Application is completed. ,

Attaching steel plates to the side of a water tower to run fiber-optic cables up to the cell phone antennas on top.

waited for the temperature to rise. Once the temperature was over 41F, they began final preparation of the tank surface and started mounting the plates working their way from the top to the bottom. Surface preparation on the tank was done with the MBX Bristle Blaster, and preparation on the plates was done with a coarse grinding wheel.

Belzona 1161 was chosen for this project because of the heavy fog and moisture in the air at that time of year at this location allowing for the project to move forward without any concerns of water delays.
