Belzona 1111 (SUPER METAL) MOUNTS CELL PHONE ANTENNAS AT 220'

ID: 5255

Customer Location: *East Lake Fenwick, WA, USA*
Application Date: *October 2013*

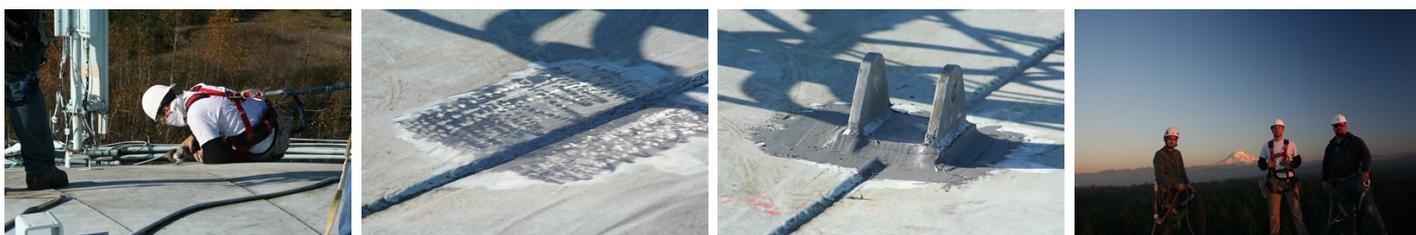
Photograph Descriptions

- * 1. Surface preparation ,
- * 2. Surface ready for application ,
- * 3. Plate mounted carefully over uneven surface ,
- * 4. Belzona technical Consultant and the crew after the job is done (Mt. Rainier in the background) ,

Standard instructions followed as stated in the IFU for the Belzona 1111. As seen in the pictures, some of the mounts were forced to be on uneven surfaces and over weld lines. Special care was taken to ensure the existing paint was removed from the rough surface of the weld without compromising the integrity of the weld itself.
