BELZONA PROTECTS EXHAUST FAN FROM EROSION

ID: 5289

Industry: Marine
Application: FBC-Fans, Blowers and Compressors

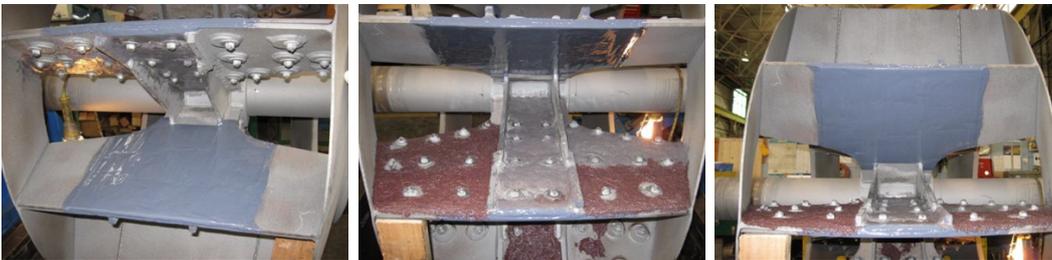
Photograph Descriptions

The fan moves hot, moist, particulate laden exhaust air from the dryers. The hot air erodes the replaceable hardened steel blade faces while the swirling mixture erodes the back faces of the fan blades, compromising its structural strength.

- * The leading faces of the fan blades are protected with Belzona 1391. ,
- * The backside of the fan blades are protected with Belzona 1811. ,
- * Completed application with both front and back of the fan blades protected. ,

Using Belzona 1811 to fair in and smooth the blade back help to reduce the swirl effect and protect the blade. On the blade faces, Belzona 1391 acts as a sacrificial coating and has proven to almost double the service life of the AR plate. It is planned to reapply Belzona 1391, when necessary, in situ to extend the service life even further.
