BELZONA REPAIRS TURBINE SHAFT AT A POWER STATION

Customer Location: Sudbury, ON, Canada
Application Date: October 2013

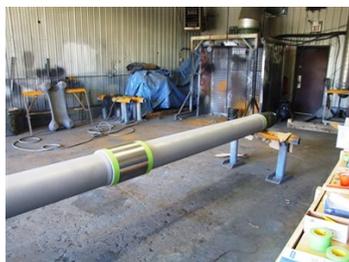
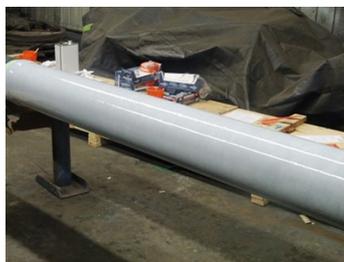
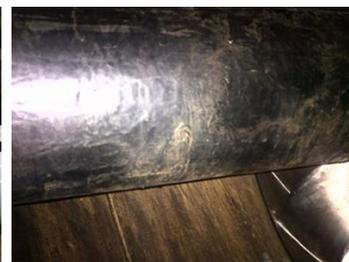
Damaged on turbine shaft was caused by cavitation, erosion and corrosion.

- * Power station ,
- * Application in progress ,
- * Completed application ,
- * Application after 6 months ,

The application was carried out in accordance with Belzona Know-How System Leaflet CEP-4 for applying external coatings. Belzona 1341 was applied to the surface using a brush. In the smaller sections of the turbine shaft, Belzona 2941 and Belzona 2141 were applied using a brush in accordance with Belzona Instructions For Use.
