BELZONA PROTECTS MAIN ON A MIXING TRUCK AGAINST ABRASION

ID: 5316

Application: SHM-Solids Handling Machinery

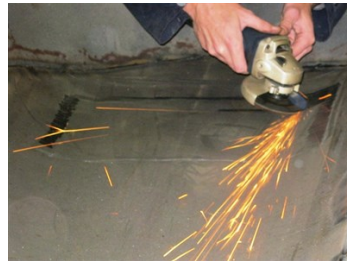
Impact and abrasion caused by flowing concrete.

- * Concrete mixing truck ,
- * Main prior to application ,
- * Preparation in process ,
- * Completed application ,

The application was carried out in accordance with Belzona Know-How System Leaflet SHM-13 for lining chutes and hoppers. The area was prepared using a hand grinder to create a cross hatch profile pattern. Belzona 1812 was applied directly onto the prepared surface with a plastic applicator in accordance with Belzona Instructions For Use.
