# BELZONA STEPS UP TO THE CHALLENGE

ID: 5319

**Industry:** Buildings & Structures  
**Application:** FPA-Floor Problem Areas  
**Substrate:** Concrete  
**Products:** \* Belzona 4131 (Magma-Screed) ,  
\* Belzona 4911 (Magma TX Conditioner) ,

**Customer Location:** Waterloo, ON, Canada  
**Application Date:** June 2011

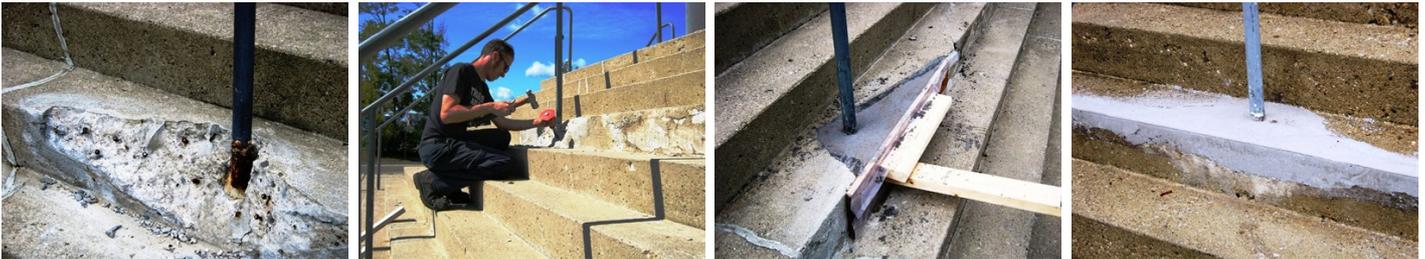
## Photograph Descriptions

Spalled concrete around hand rail post.

- \* Prior to application ,
- \* Preparation in process ,
- \* Application in process ,
- \* Completed application ,

The application was carried out in accordance with Belzona Know-How System Leaflet FPA-1 for rebuilding worn and damaged floor surfaces. The step around the hand rail was prepared by removing any loose material. Belzona 4911 (Magma TX Conditioner) was applied using a brush and Belzona 4131 was applied directly on to the conditioned surface, initially spreading to a general level using normal screeding techniques and then using a metal straight edge.
