# BELZONA SECURES AERATION BASIN JOINTS

**Industry:** Water / Wastewater  
**Application:** FPA-Floor Problem Areas  
**Substrate:** Concrete  
**Products:** \* Belzona 2211 (MP Hi-Build Elastomer) ,  
\* Belzona 2911 (Elastomer QD Conditioner) ,

**Customer Location:** Anacortes, WA, USA  
**Application Date:** July 2010

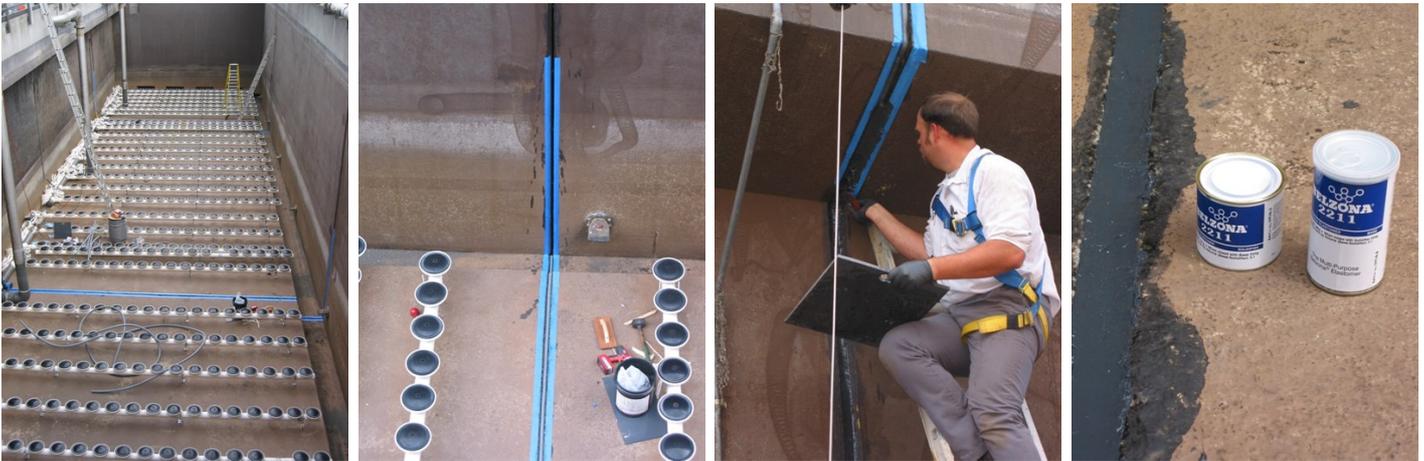
The client was aware of Belzona's quality and sought use of appropriate Belzona materials to seal leaking expansion joints. Existing material was of poor quality and had torn away from joint sidewalls.

- \* Aeration basin overview ,
- \* Masking, backer rod & conditioner applied ,
- \* Application to overhead & vertical wall surfaces ,
- \* Completed joint ,

The application was carried out in accordance with Belzona Know-How System Leaflet FPA-6. A foam backer rod was inserted to expansion joint the proper depth. Belzona 2911 was used to condition the surface area and Belzona 2111 was hand applied to seal the expansion joint.
